1983 ENVIRONMENTAL MONITORING REPORT U.S. DEPARTMENT OF ENERGY FACILITIES GRAND JUNCTION, COLORADO, AND MONTICELLO, UTAH

Nic Korte and Ralph Thul
Bendix Field Engineering Corporation
Grand Junction Operations
Grand Junction, Colorado 81502

March 1984

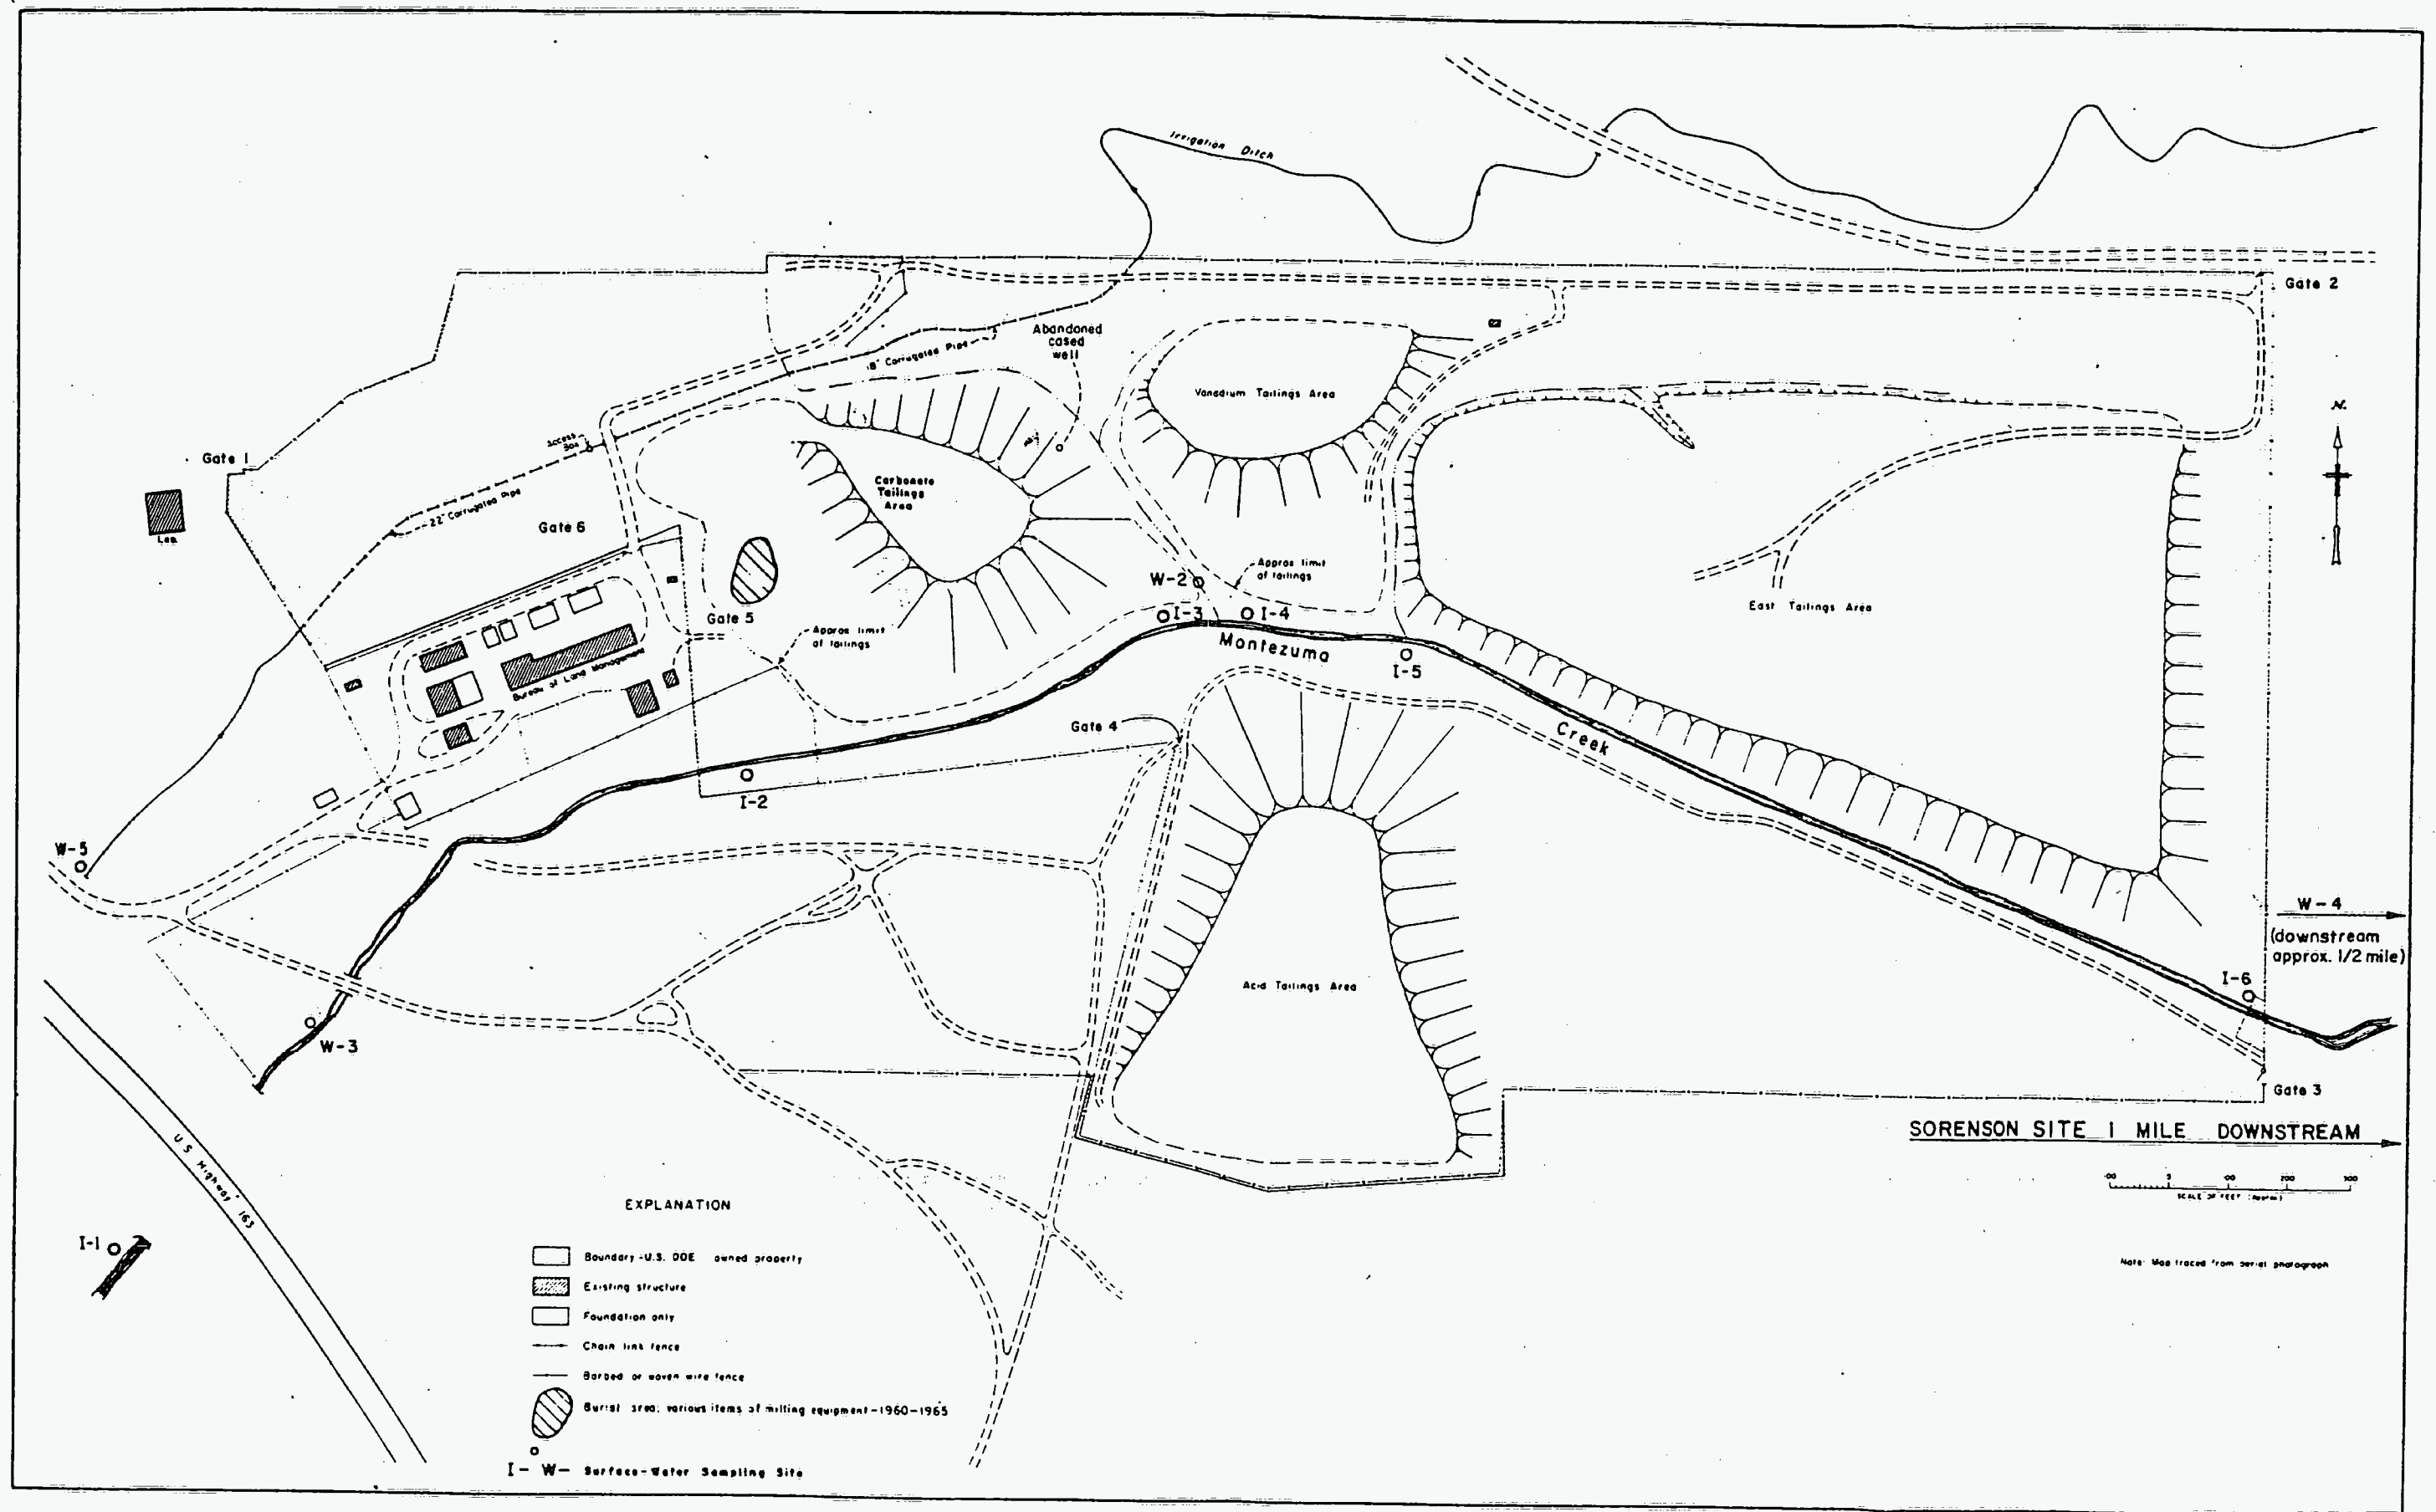
Figure IV-1. Sampling Locations for Surface Water at the Monticello Millsite

Permanent surface water on the Government property consists of perennial flow in Montezuma Creek and in the drainage between the carbonate and vanadium piles (drainage designated W-2 on the map in Figure IV-1). There is intermittent water in seeps south of the carbonate and vanadium piles and east of the acid pile. The vanadium and acid pile seeps contain water in the Spring following snowmelt. The seep adjacent to the vanadium pile generally covers an area up to 5 square meters to a depth of 15 to 30 centimeters. The acid pile seep is contained by a small dam and is, when full, approximately four times larger in area than the vanadium pile seep.

The seep adjacent to the carbonate pile forms a small pond covering approximately 15 square meters. This pond contains water throughout the Summer and supports a few cattails; it is the only one of the three seeps that contains water during the dry seasons. Table IV-1 presents data obtained from analyses of water taken from the seeps and the W-2 drainage; very high concentrations of several toxic elements are evident.

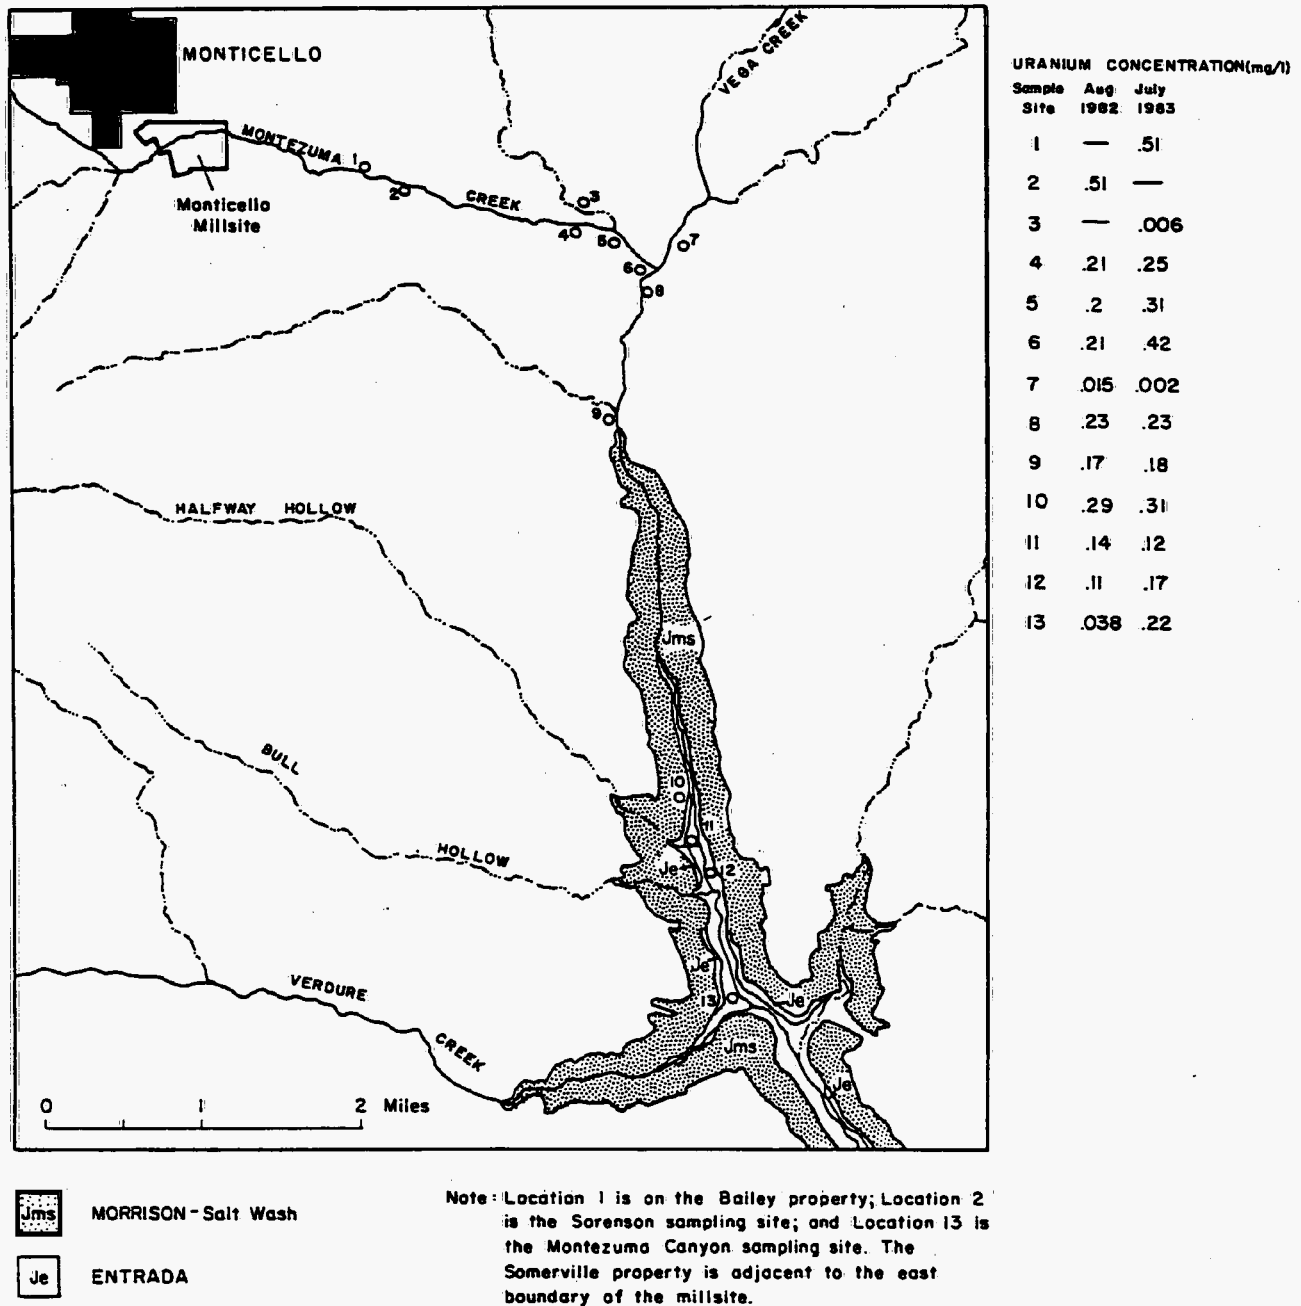
Figure IV-2. Sampling Locations and Associated Uranium Concentrations in Montezuma Creek (from Abramiuk and others, 1983)

The water in the main canyon was sampled above and below each tributary to delineate possible uranium sources. Figure IV-2 presents the results obtained from sample analysis. In August 1982, uranium concentrations approximated 0.2 mg/l to the point that the creek begins to cut the Morrison Formation. Increases in uranium, molybdenum, and vanadium concentrations were observable below the Morrison. This is not surprising since uranium mineralization in the Morrison is common in the study area (Huff and Lesure, 1965). Contamination was not observed from any of the side canyons.

The data from the July 1983 sampling trip, shown in Figure IV-2, depict the conditions which exist for most of the year. The most significant of these are the following:

- Seeps issuing from the contaminated alluvial aquifer increase the concentration of uranium in the creek by approximately an order of magnitude--up to several tenths of a milligram per liter. These seeps are most evident in the first 50 to 100 meters downstream from the Government property line.
- The Morrison Formation contributes significant amounts of uranium to Montezuma Creek at a point approximately 6.5 kilometers downstream from the piles. This contribution is responsible, in part, for maintaining the high uranium concentrations (Table IV-3) observed at the Montezuma Canyon site.

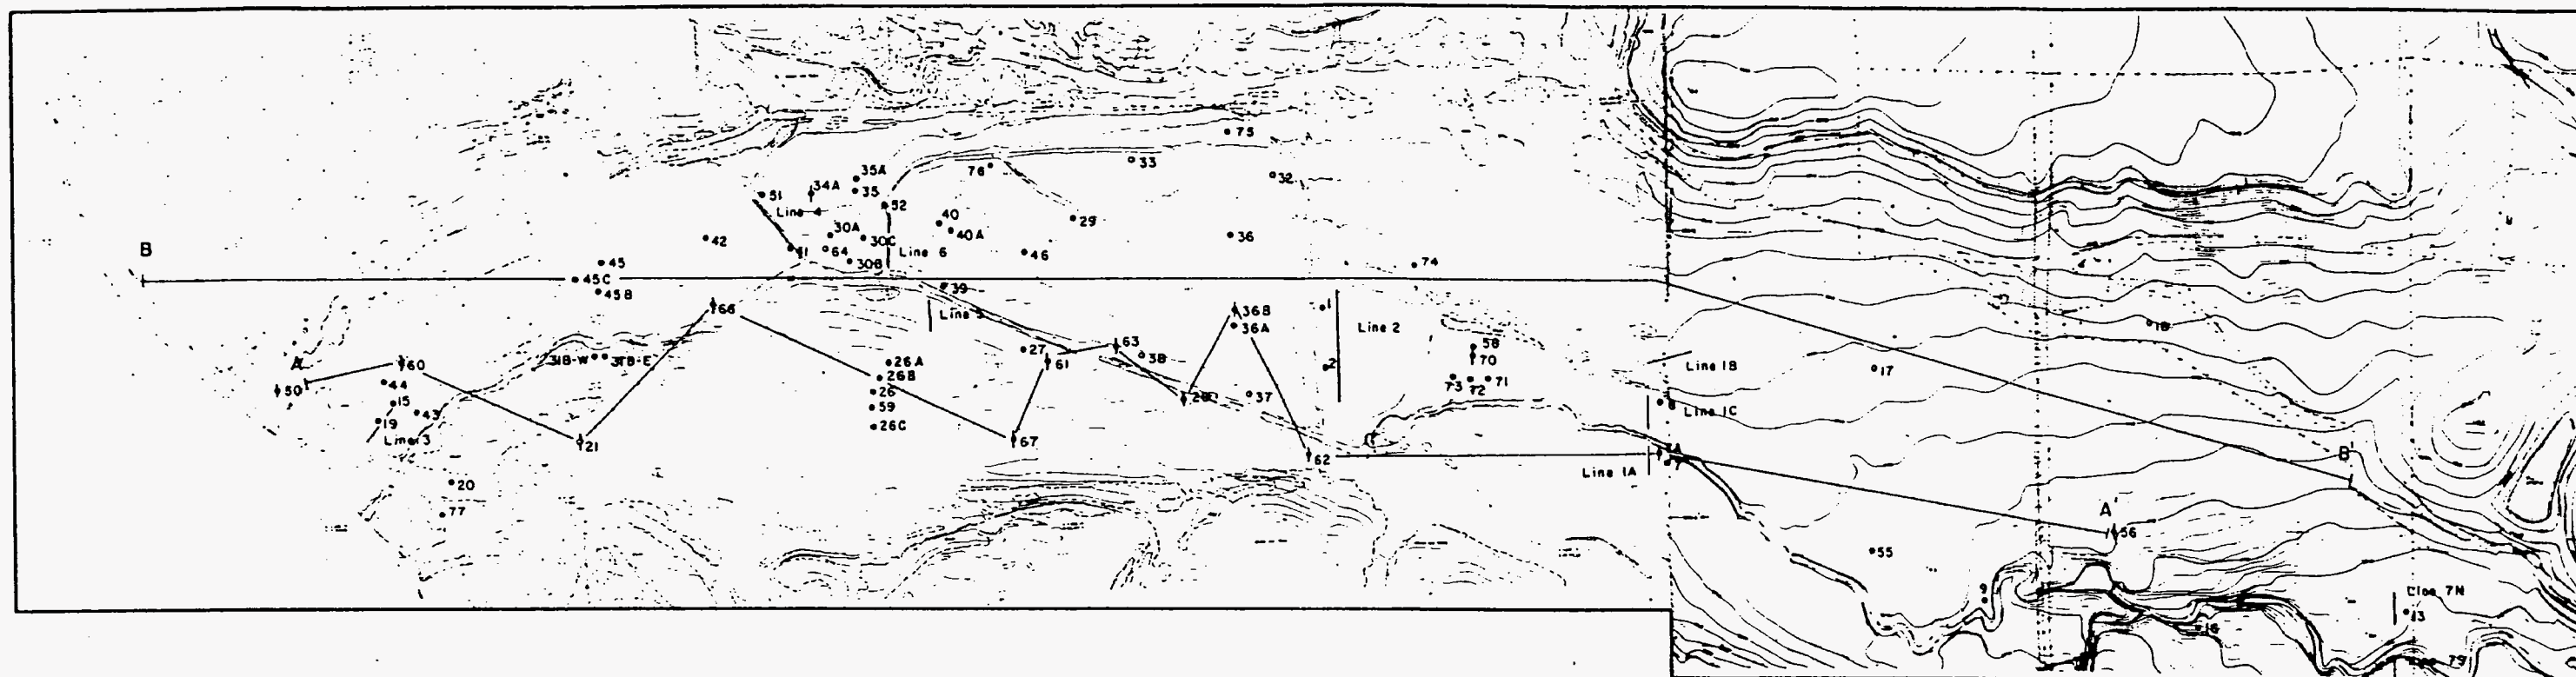
Shallow-aquifer background groundwater quality data have been acquired from Wells 19, 44, 43, and 20 (see Figure IV-3). Elements not detected or found in very low concentrations include Ag, Al, As, Ba, Cd, Co, Cr, F, Fe, Hg, Mo, P, Pb, Se, V, and Ra. Trace elements found in significant concentrations include Mn (1.5 to 3 mg/l), Zn (0.05 to 0.2 mg/l), and U (as much as 0.07 ppb in two samples). The pH was found to range from 6.8 to 7.2; specific conductance was measured at 600 to 700 μ mhos/cm, and alkalinity at 250 to 500 mg/l.

The shallow aquifer is contaminated by the mill-tailings piles (Table IV-4). In general, the highest concentrations, including that of Ra-226 (Well 41), are found in the vicinity of the carbonate and vanadium piles. Note that the high uranium content of Well 36A on the east side of the east tailings pile is reflected in Wells 1 and 2 on the Somerville property.

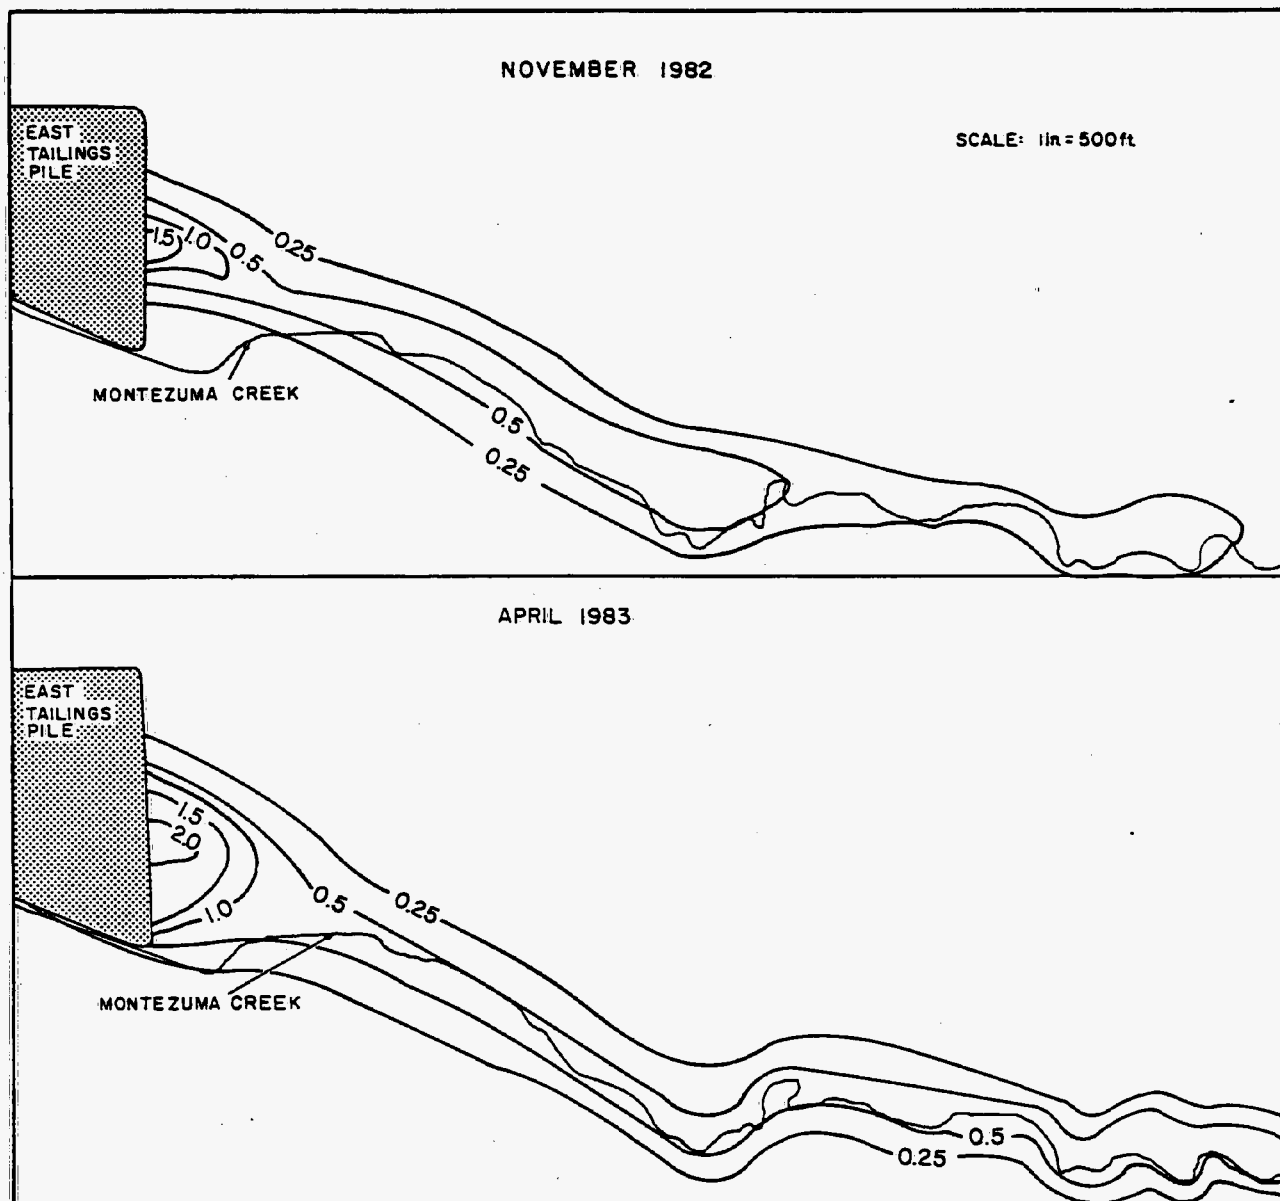
Figure IV-4. Contaminant Plumes for Uranium (in mg/l) Downgradient from the Tailings Piles in November 1982 and April 1983 (from Abramiuk and others, 1983)

Contaminant Plume - Figure IV-4 shows the contaminant plumes that existed downgradient from the tailings piles in November 1982 and April 1983. Substantial increases in contaminant concentration levels were observed between those dates, probably because of low runoff in the Montezuma Creek watershed following the dry winter of 1981/1982. As a consequence, dilution of the groundwater by an influx of surface water was minimal, permitting the contaminant plume to migrate further downgradient. Both plumes appear to follow the historic stream channel adjacent to the east pile. As the contaminants continue downgradient, they become confined to the narrow alluvium bordering the present-day stream channel.
